NATIONAL TRANSPORTATION SAFETY BOARD

TRANSPORTATION SAFETY RECOMMENDATIONS

ADOPTED DURING THE MONTH
OF DECEMBER, 1998

In reply refer to: A-98-125 and -126

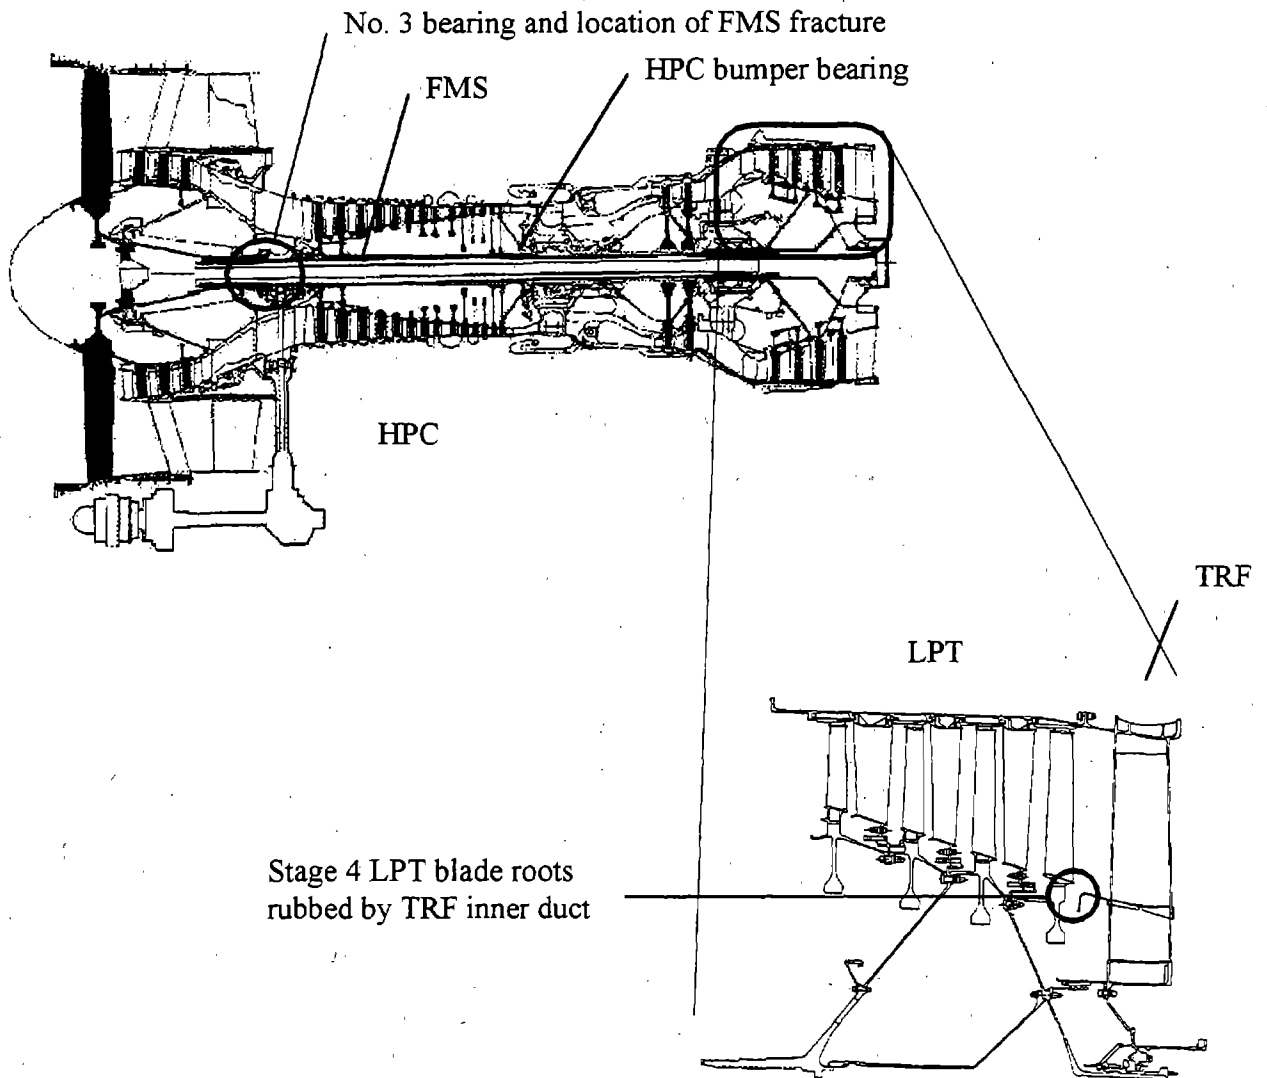
The examination of the No. 2 engine revealed that most of the LPT module was missing (see figure 1). The airplane had punctures to its left wing leading edge slats and to a landing gear door. In addition, the No. 1 engine had hard body impact damage⁴ to 18 of the 38 fan blades, and the fan cowl had impact damage from the debris ejected from the No. 2 engine.

Figure 1. Cross section of CF6-50 engine and expanded view of LPT module

Examination of the fractured FMS by the Safety Board's and GE's materials laboratories revealed a fatigue fracture with multiple origins on the outer diameter (OD) of the shaft that propagated inward. The examinations also revealed a color variation across the fracture surface and a reduction of the material hardness at the fracture in comparison to the other areas of the FMS and the engineering drawing specification, indicating that the part had been previously

The disassembly of the PIA engine showed that the center section of the FMS had become wedged into the high pressure compressor (HPC) bumper bearings. The design of the CF6-50 engine's FMS is such that the OD of the forward half of the shaft is greater than the inner diameter of the bumper bearing on the inside of the HPC rear hub. On the PIA engine, when the FMS fractured at its forward end, the rear section moved aft, and the larger diameter section of the shaft became wedged into the bumper bearing, limiting the rearward movement of the LPT

Require General Electric Aircraft Engines to modify the CF6-50 engine to eliminate the impediments to the aft translation of the low pressure turbine rotor that limits the amount of meshing that occurs in the event of a fan midshaft fracture. (A-98-125)

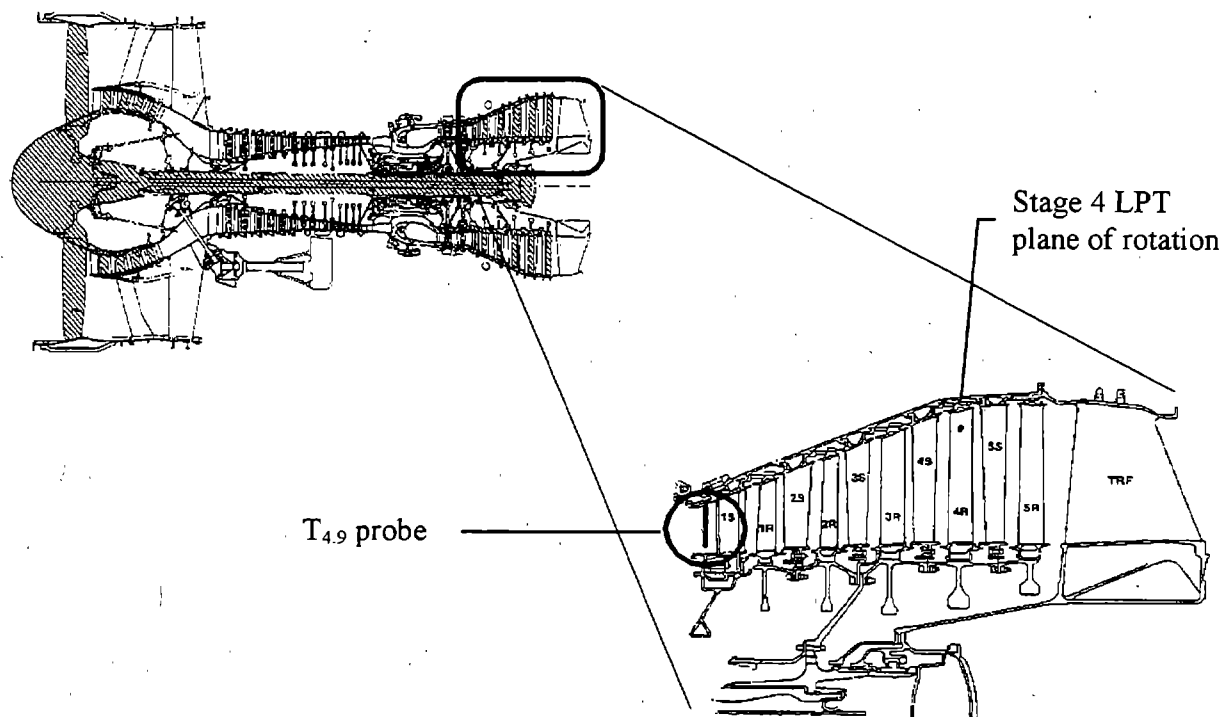
The engine was disassembled and examined under the direction of the Safety Board at Motoren-und Turbinen-Union (MTU), Hannover, Germany.¹⁵ The disassembly revealed that the tip of one interturbine temperature ($T_{4.9}$)¹⁶ probe had broken off and impacted one stage 1 LPT blade, causing a fatigue fracture of the airfoil near the blade tip shroud (see figure 2). All of the stage 2, 3, 4, and 5 LPT blades were found in their respective disks; however, all were fractured transversely across the airfoils at various lengths above the blade root platforms. The disassembly also revealed that the LPT case had a 17-inch by 2-inch wide hole in the stage 4 LPT plane of rotation. The damage to the LPT rotor was progressively worse along the gaspath, suggesting that the stage 1 LPT blade tip separated first, that all of the blades in the following stages were then fractured, and that the mass of material became larger as it progressed through the rotor, subsequently resulting in a case rupture in the stage 4 area.

Figure 2. Cross section of CF6-80C2 engine and expanded view of LPT module

Require General Electric Aircraft Engines to improve the ability of the CF6-50 and the CF6-80 series engines to prevent fractured low pressure turbine blades from being liberated through the engine cowling. (A-98-126)
